MACINTYRE REALTIES

APPRAISAL REPORT

of the buildings and other structures
located on the property of the
Gatineau Yacht Club.

This property being two islands in
the Gatineau River at Gleneagle,
West Hull, Quebec.

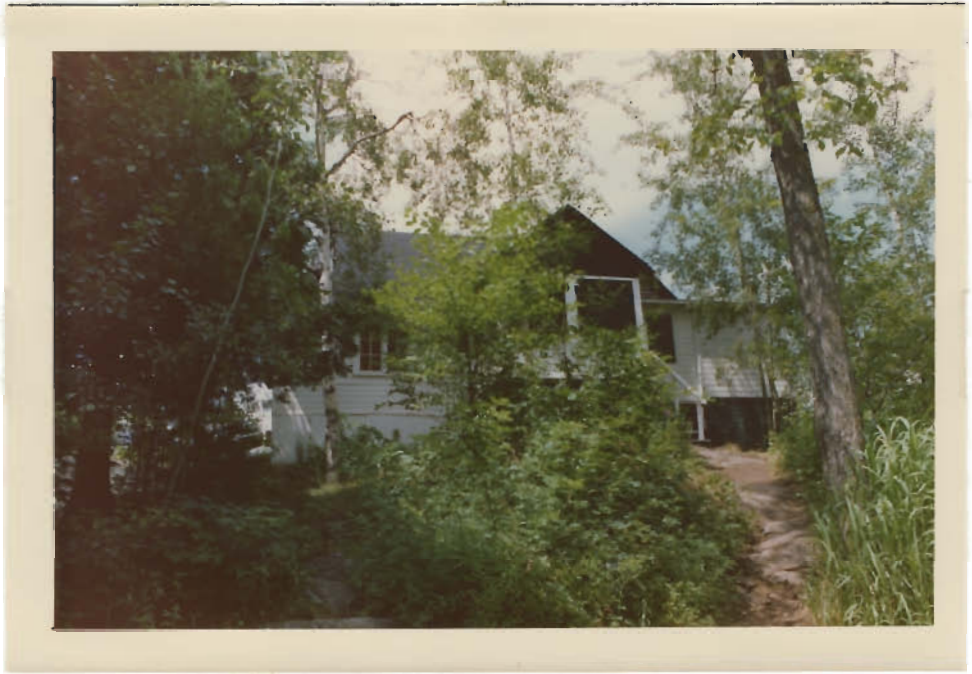
Back of club house as seen from cleared area from end of boom.

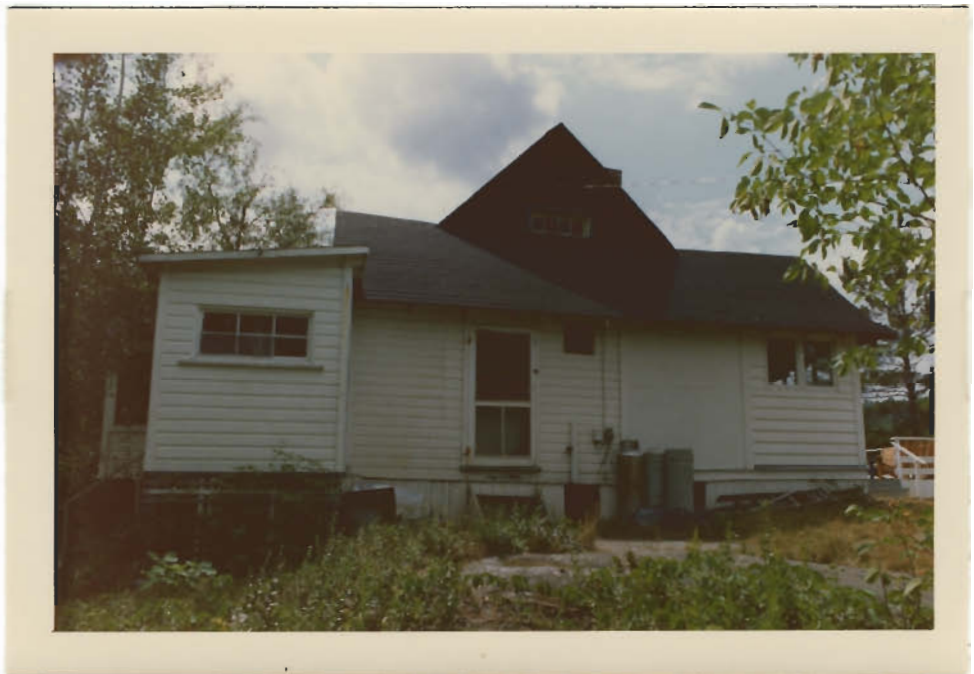
North East side of club house showing rear entrance to kitchen.

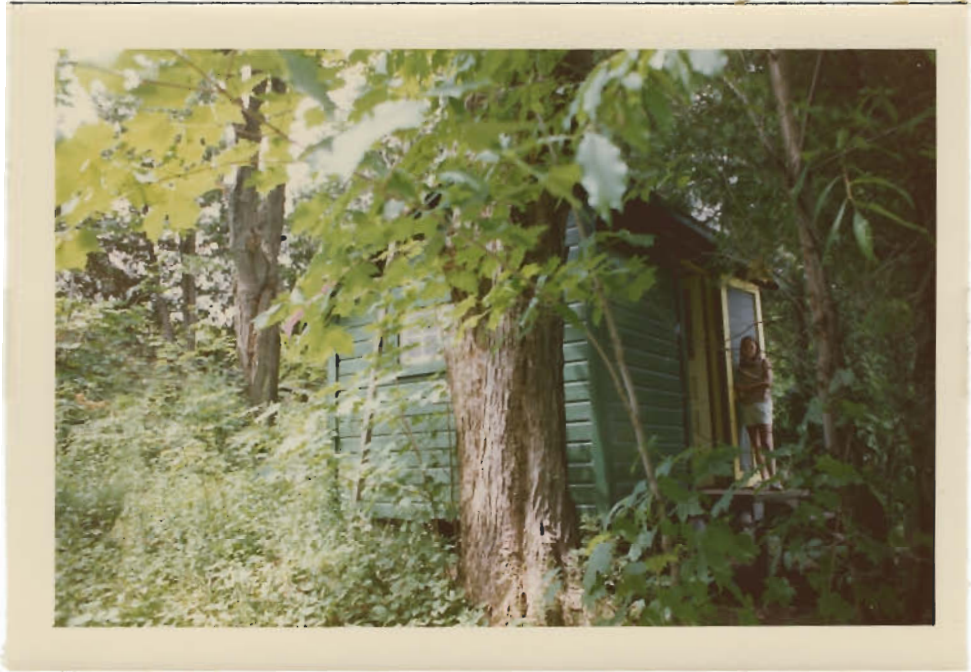
Girls changing house.

This building, as seen at the top of page 6, has a floor area of 116 sq.ft. and has a Replacement Value of approximately..... \$ 1,100.00
It is considered to be about 30% Depreciated so that its present value is approximately..... \$ 750.00
